Alaska District

BARROW STORM DAMAGE REDUCTION PROJECT

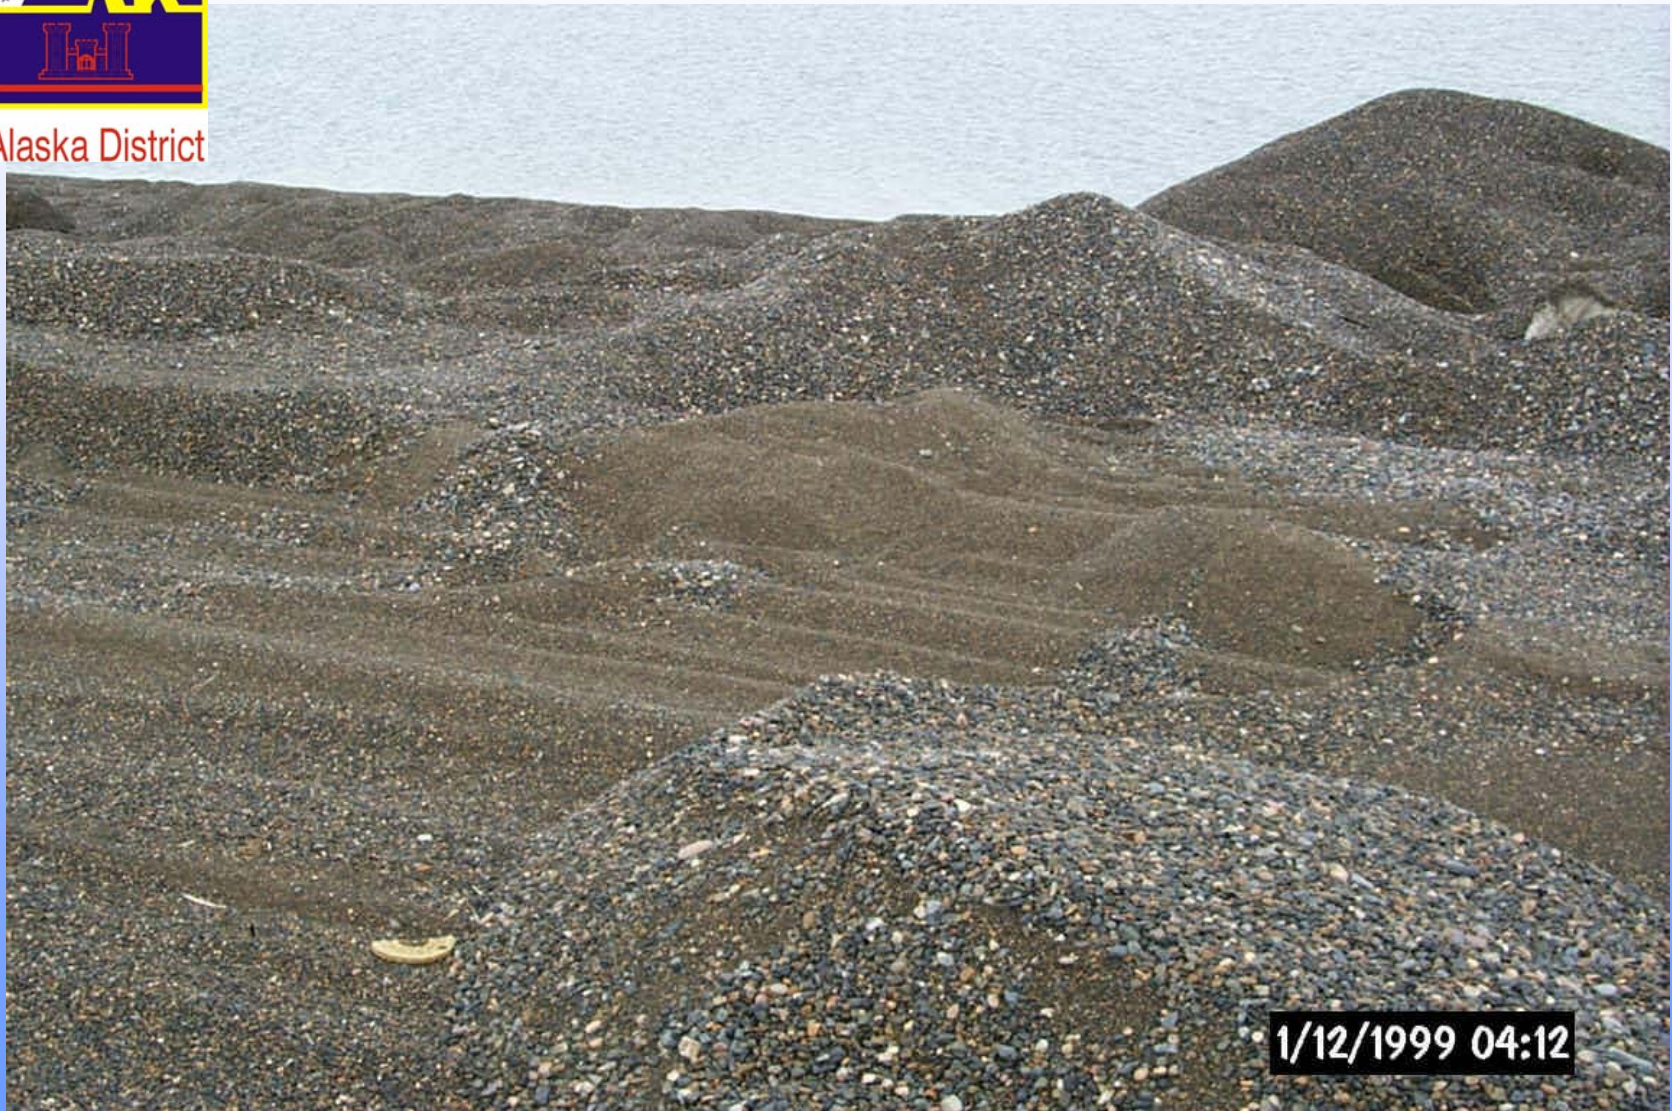
Beach is fine to coarse sand with gravel. This fronts a silt bluff with permafrost. Bluff elevation of approximately 20 feet transitions to a low lying beach between the Cities of Barrow and Browerville

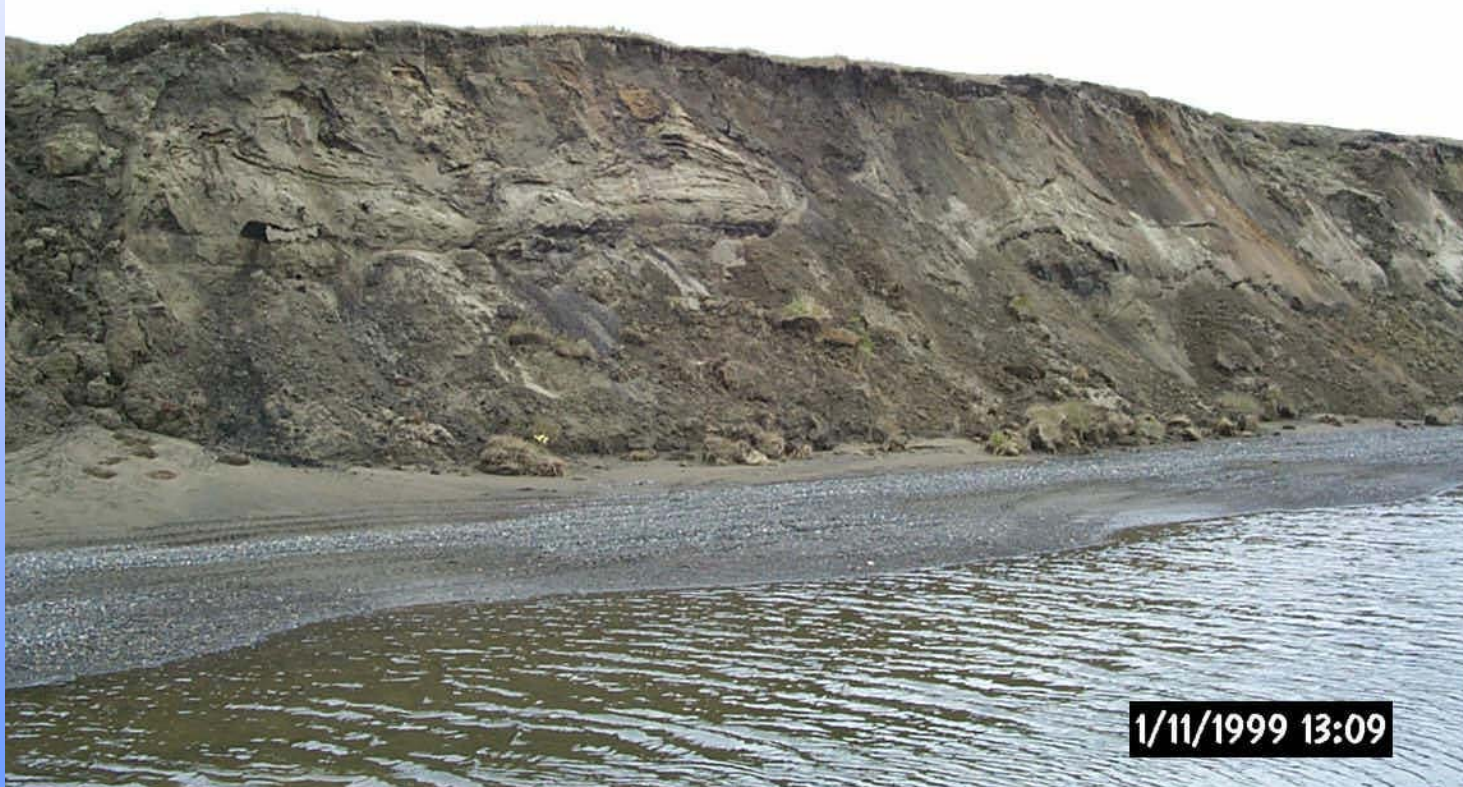
South coastline is characterized by a narrow sand/gravel beach backed by silty bluffs laden with permafrost

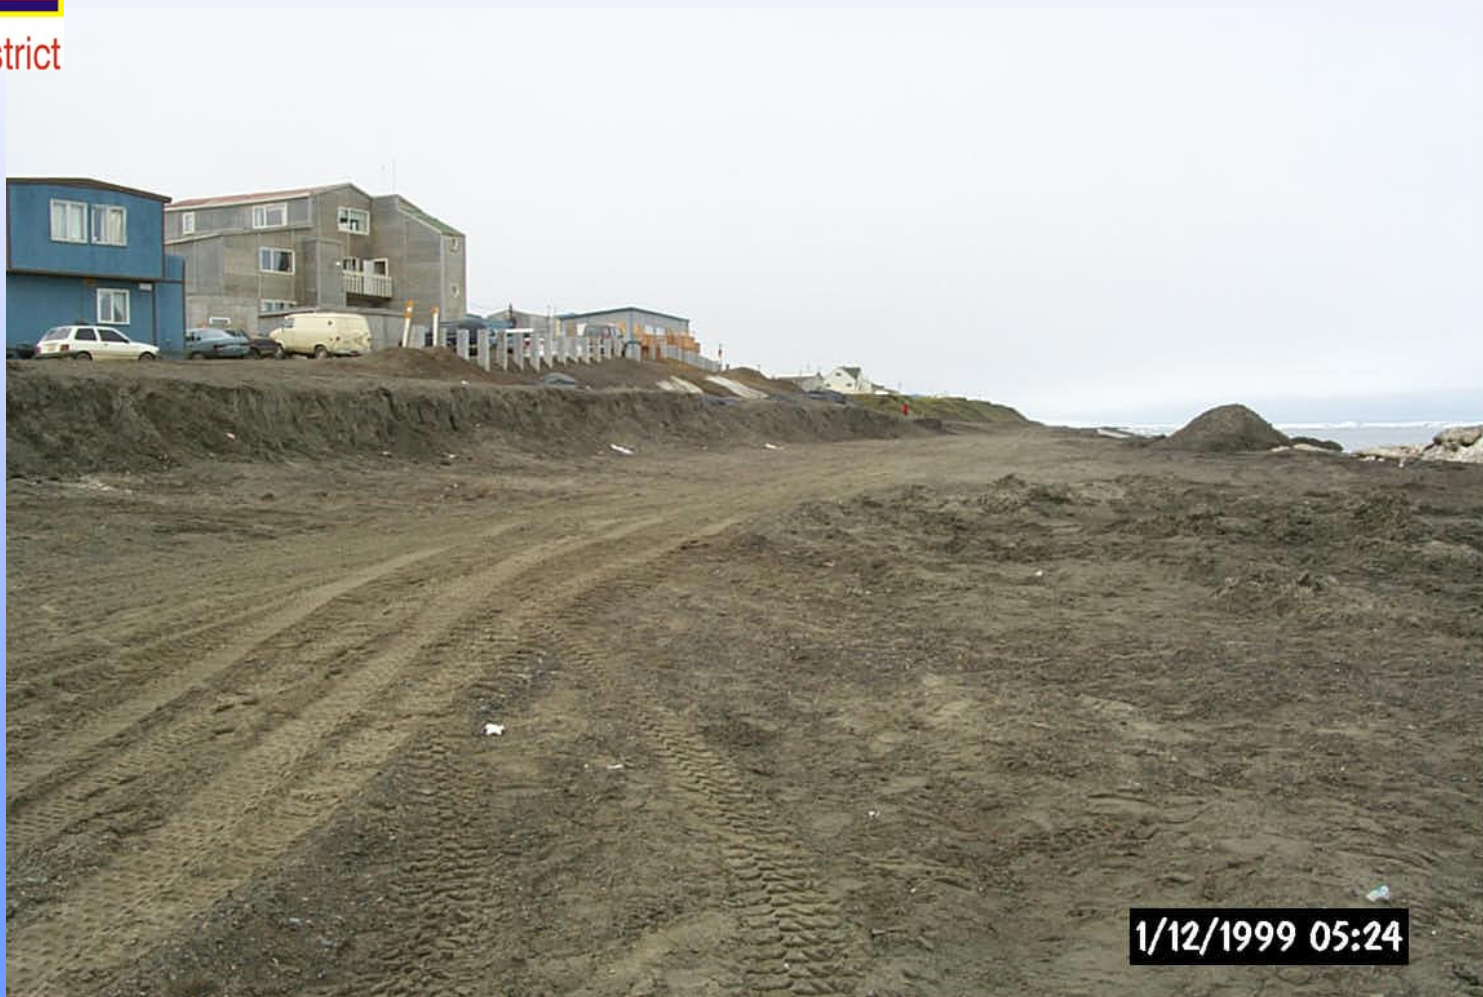
Bluff feature reduces in height as you proceed north.

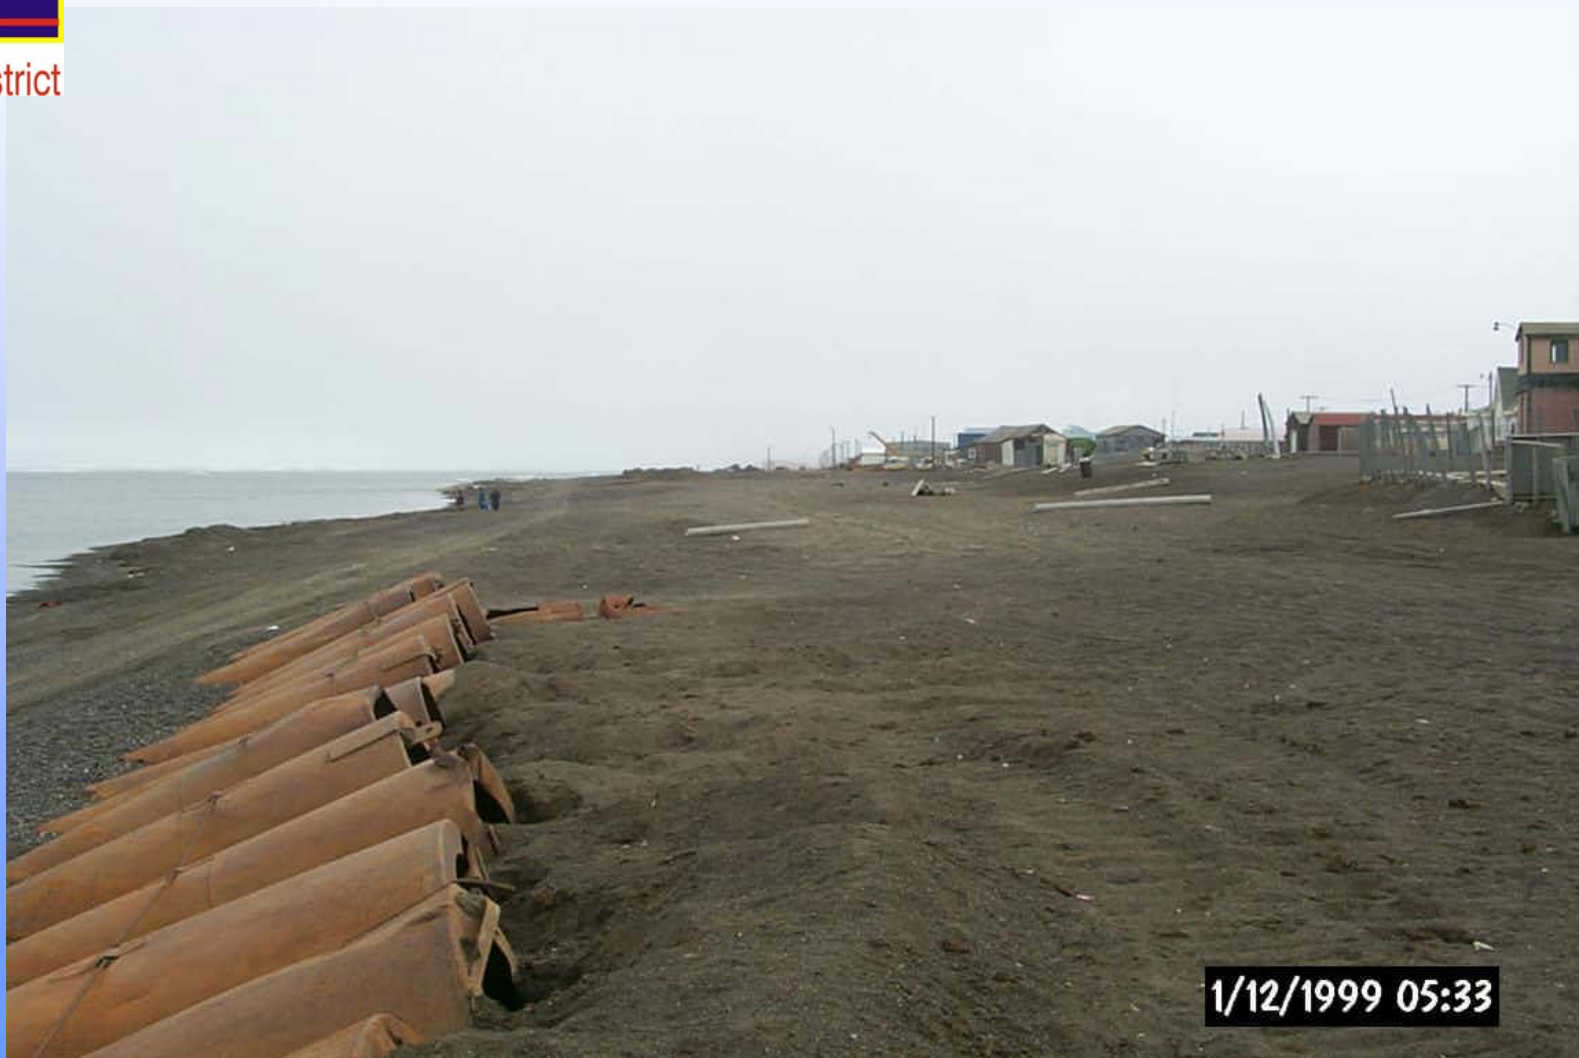
Bluff feature is no longer present at Browerville

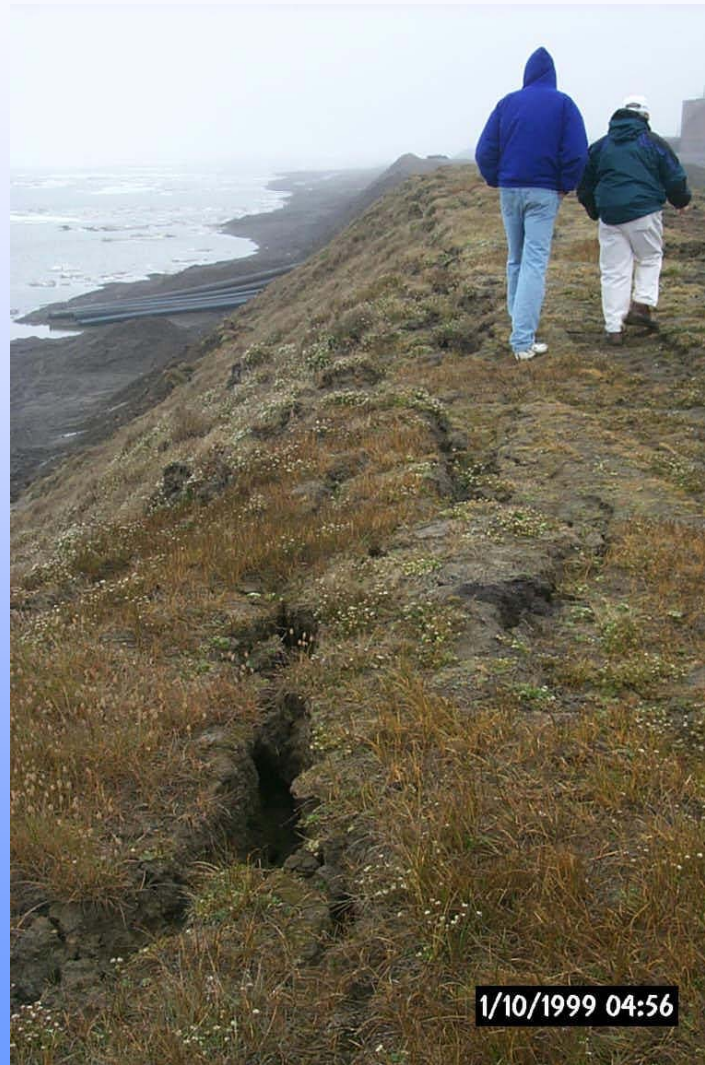
Bluff is in a weakened state due to melting permafrost and susceptibility to wave action. This is evidenced by fractures along the top of the bluffs.

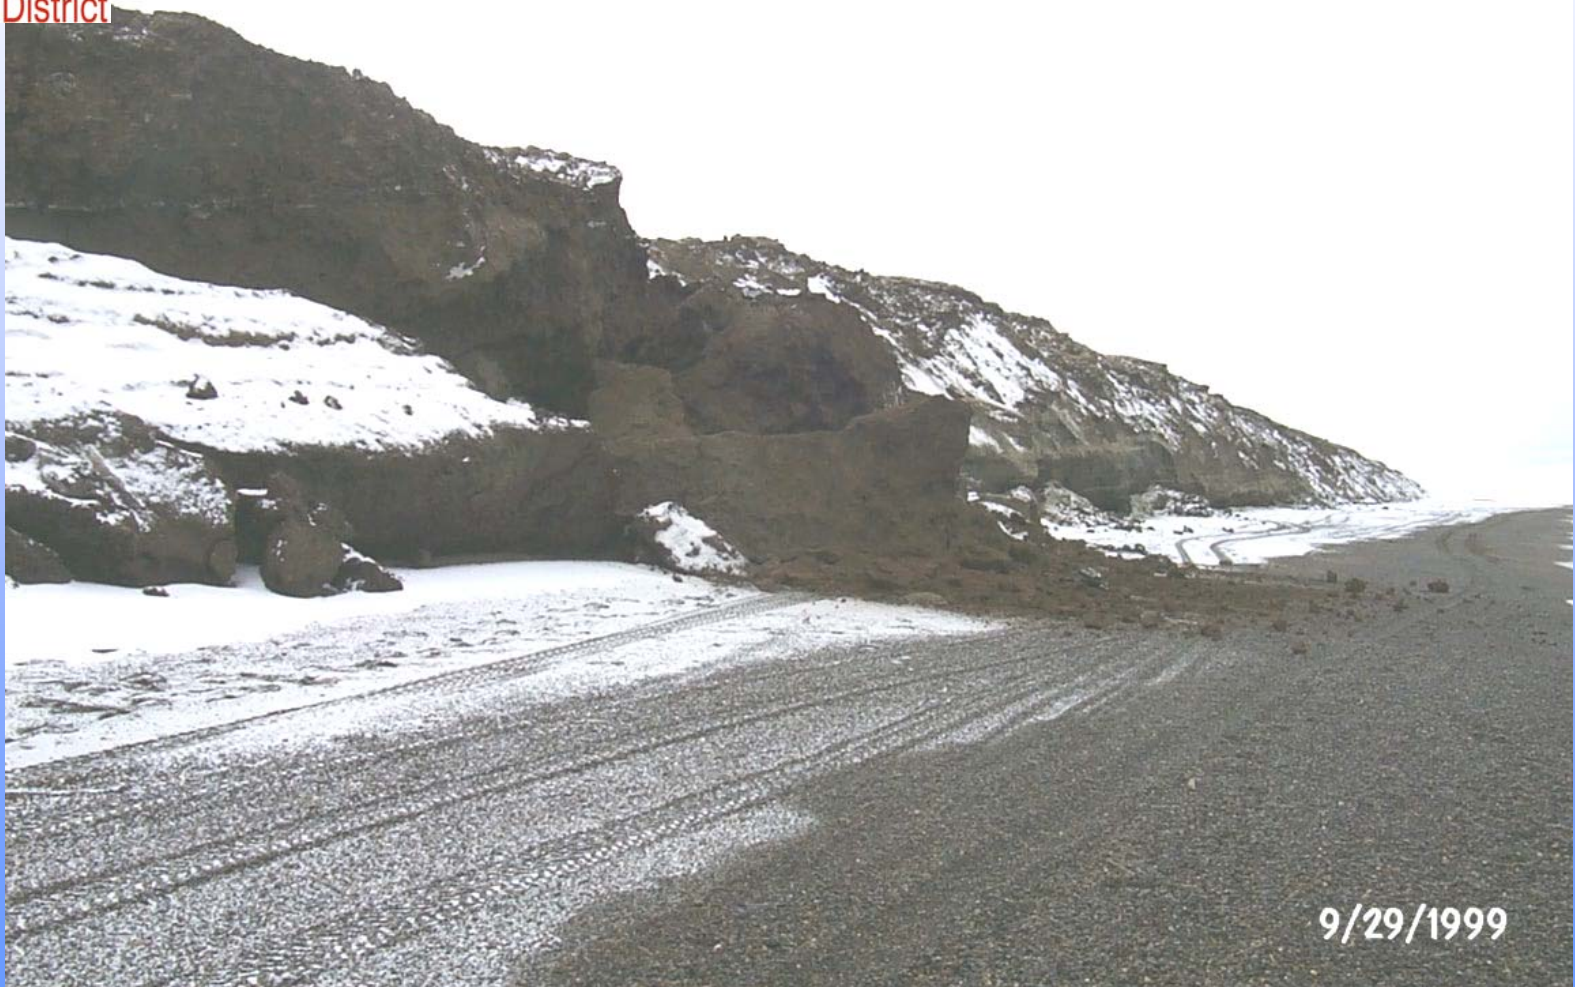
Bluff Failure from permafrost melting and wave action

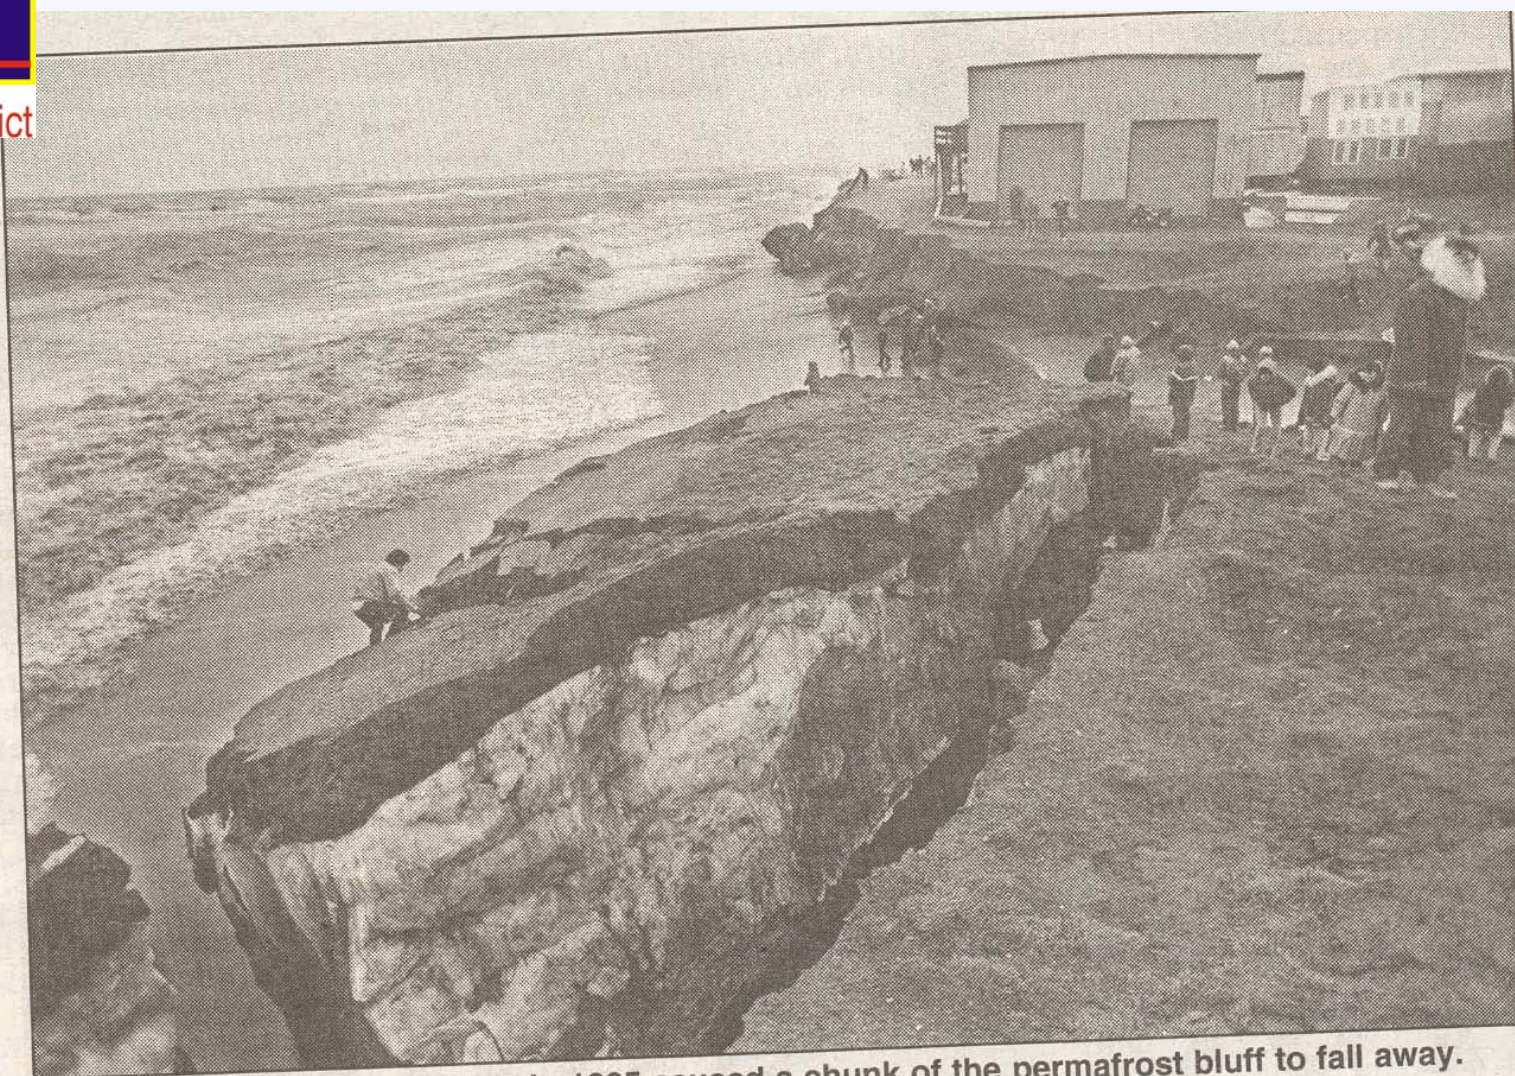
The bluff failure is generally in large sections

Autumn storms in Barrow in 1985 caused a chunk of the permafrost bluff to fall away.

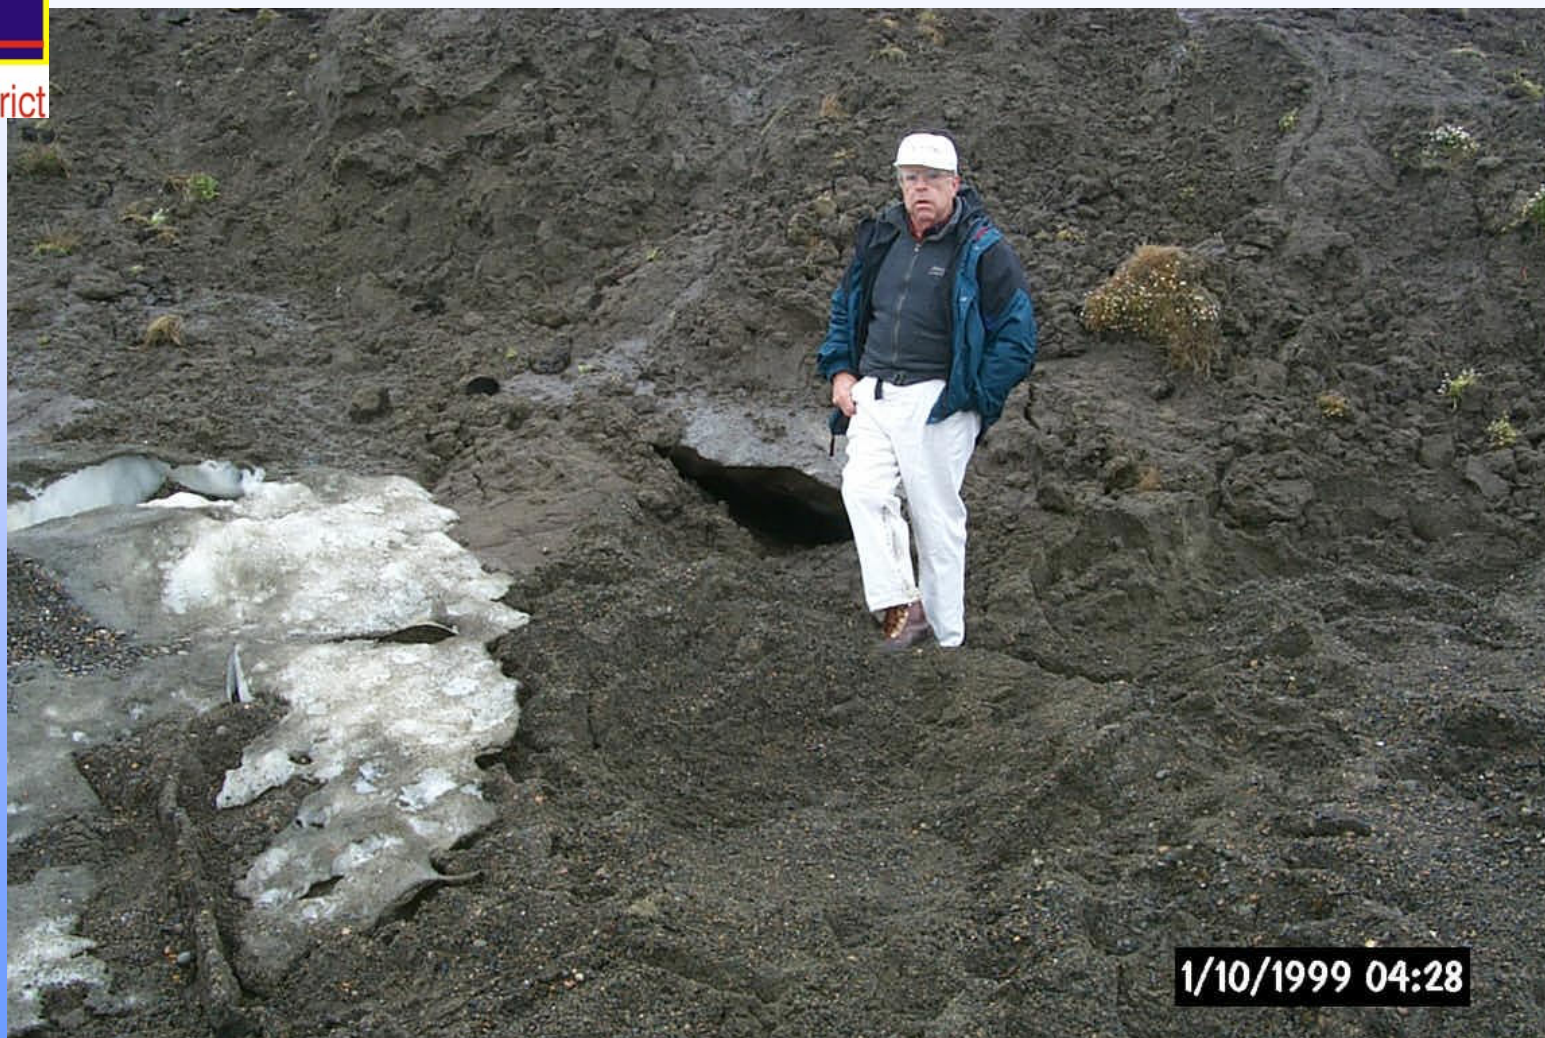
Smaller failures are in the form of mud flow where the bluffs become saturated and localized areas slump

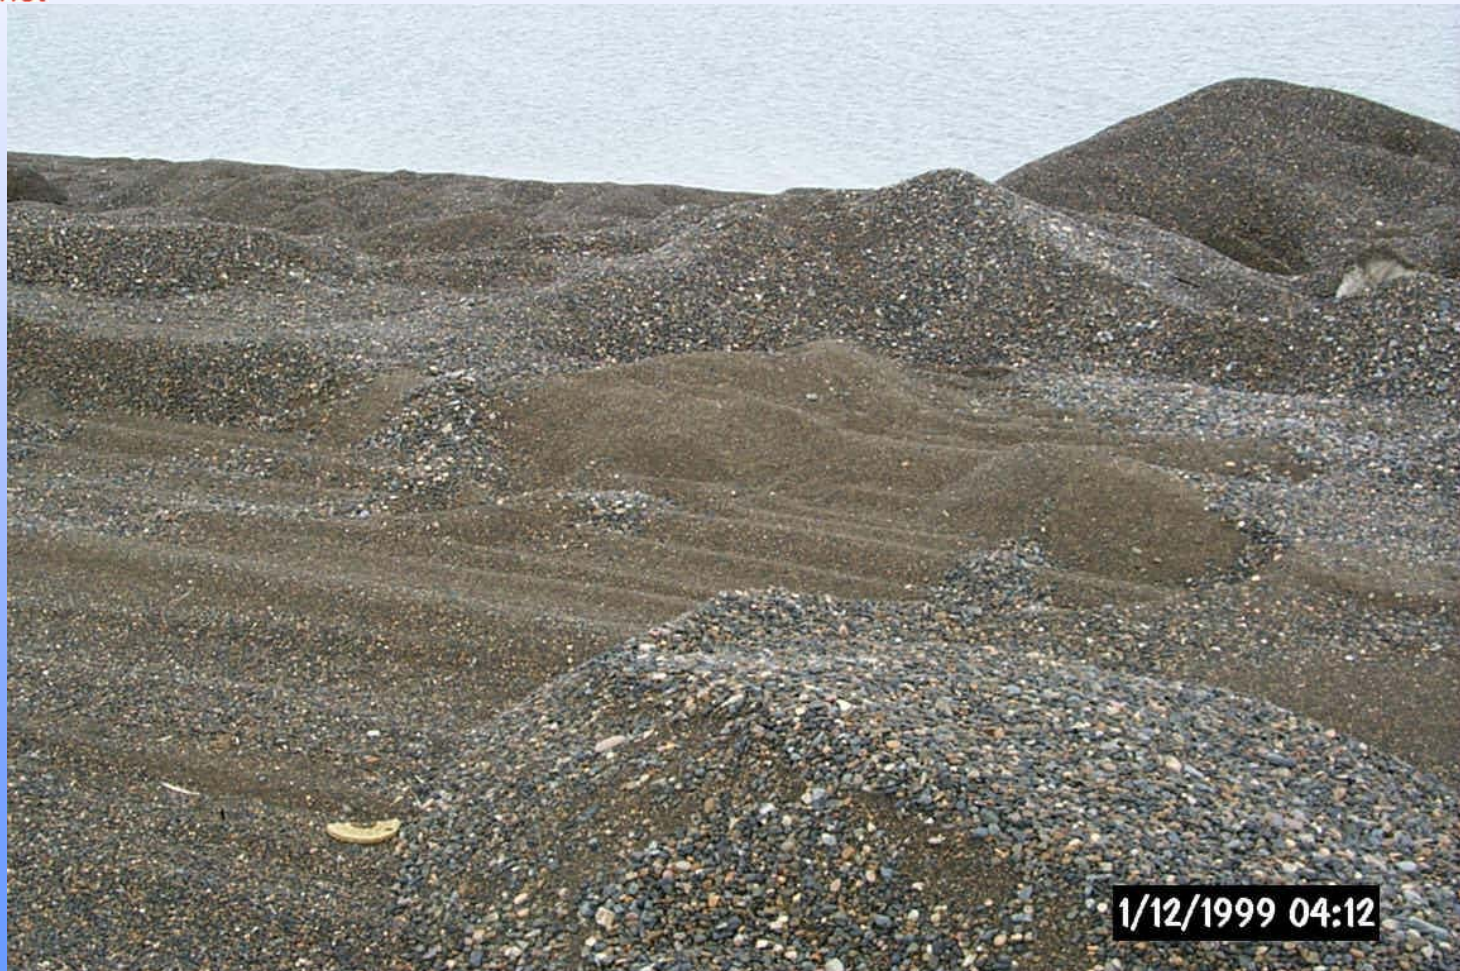
The beach material is worked every year by the ice.

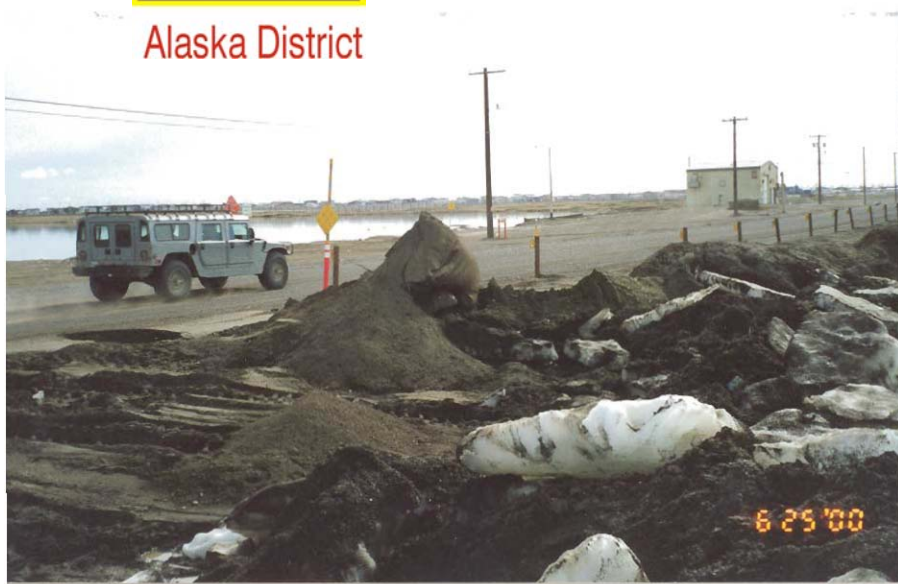
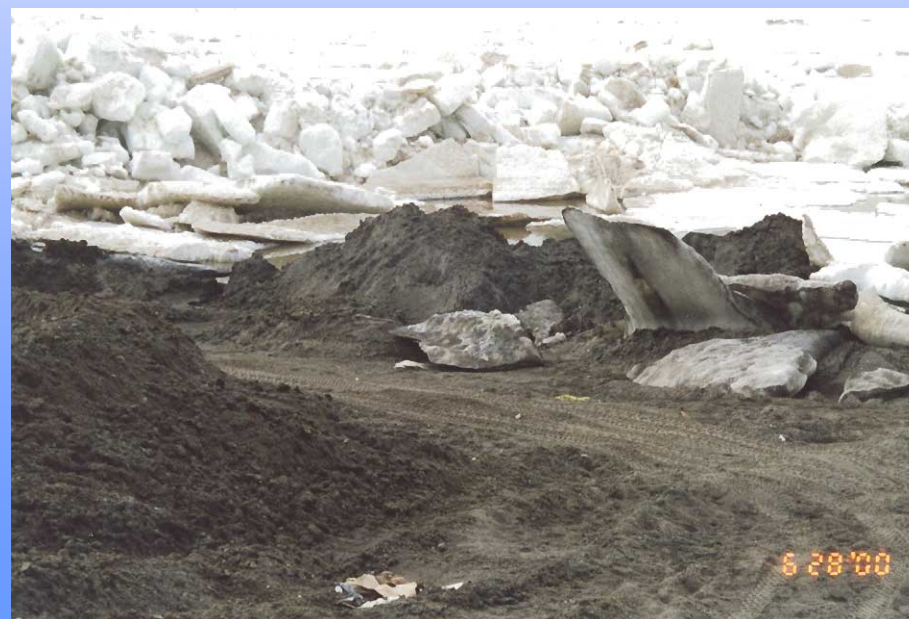
The effects of ice on the beach can be severe as in the case of an "ivu" where ice can advance quite far inland.

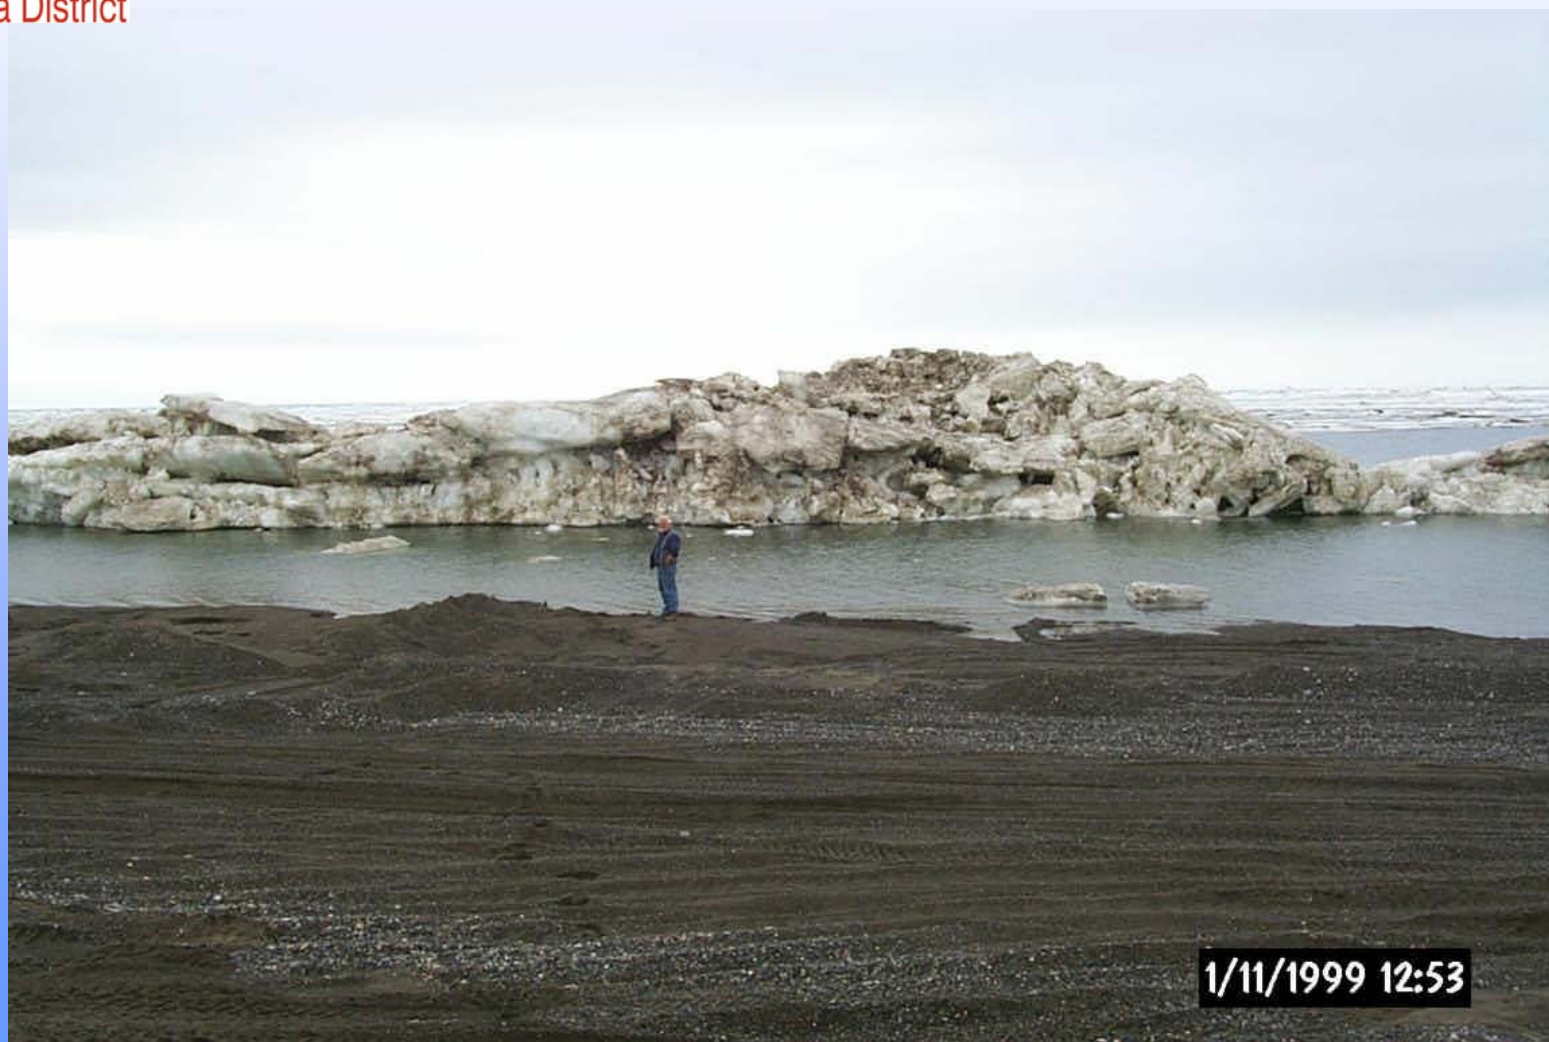
The ice provides a damping of the wave climate and can exert considerable force on structures that may get in its way

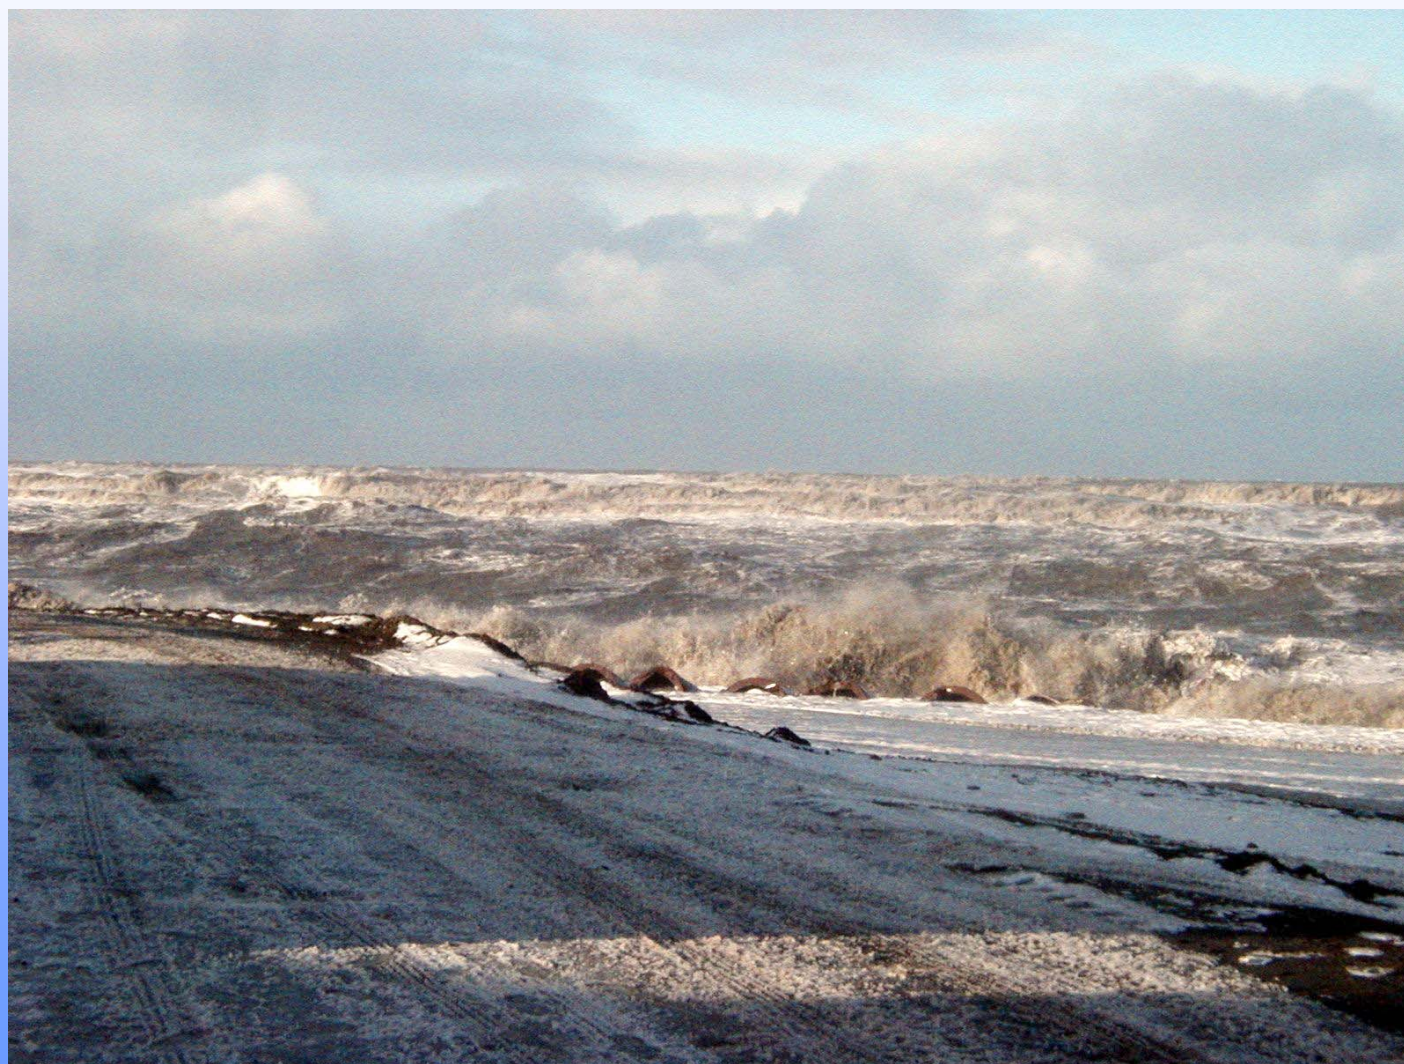
The ice has generally been staying offshore later into the summer, resulting in an increased window for storms to occur (2002).

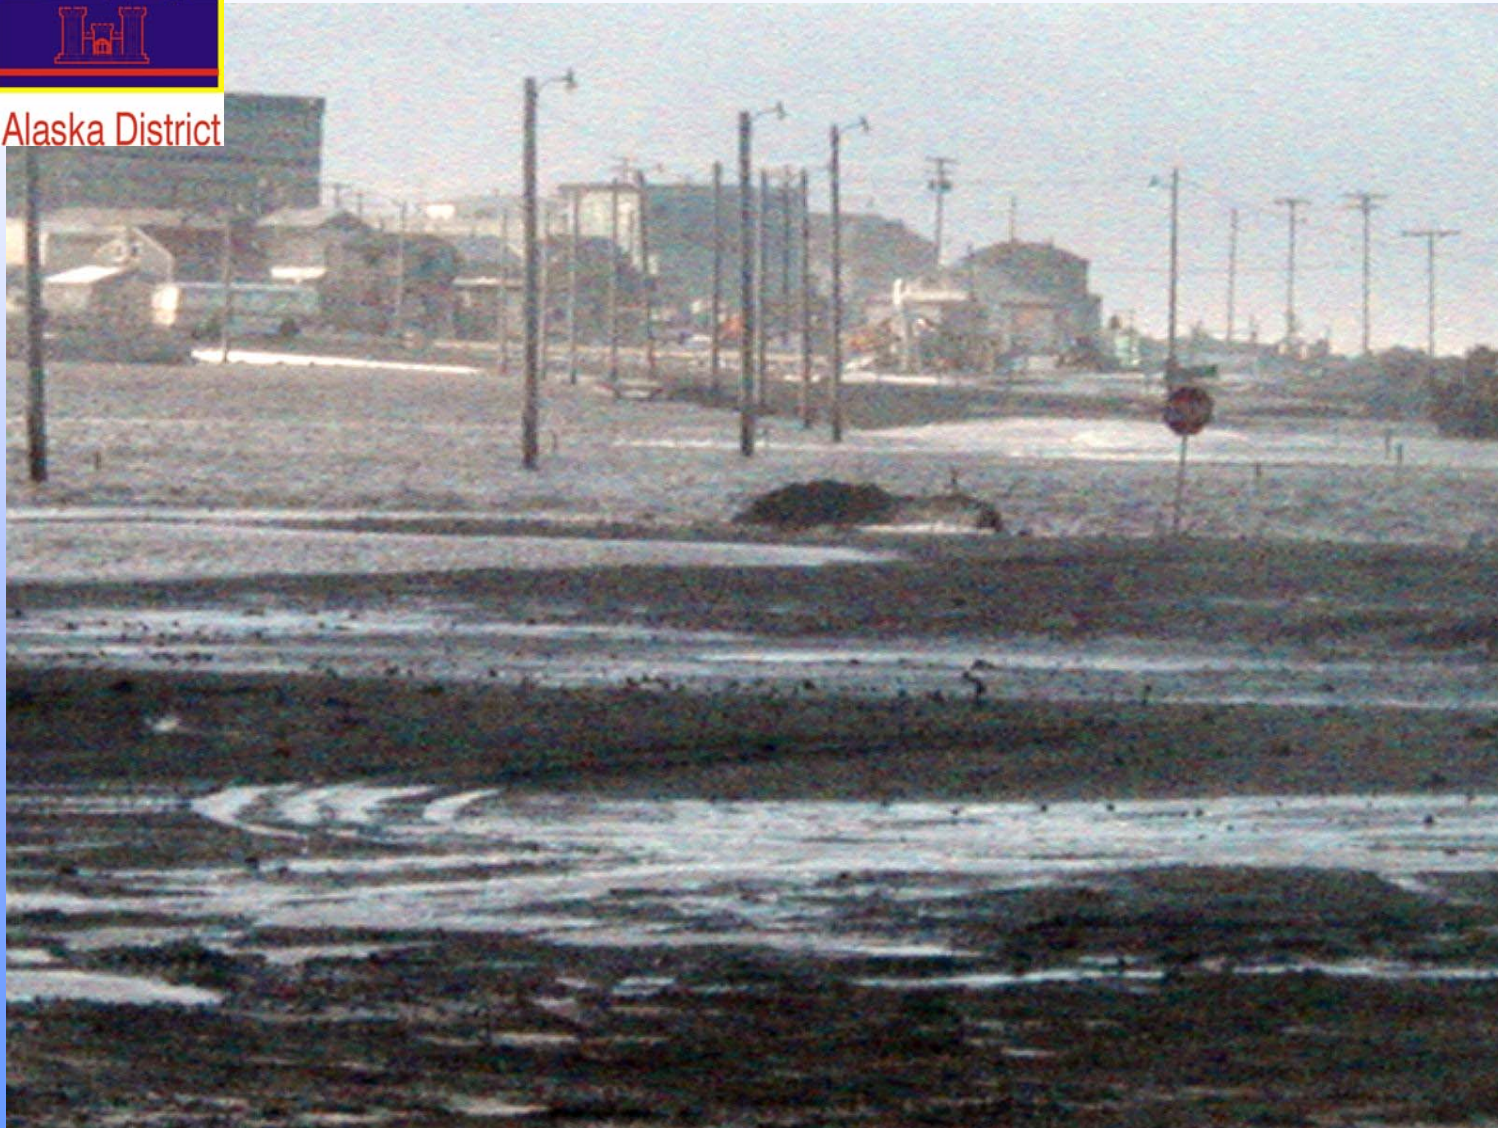
In addition to the bluff impacts, the storms bring flooding with water surge and wave set up effects (2002).

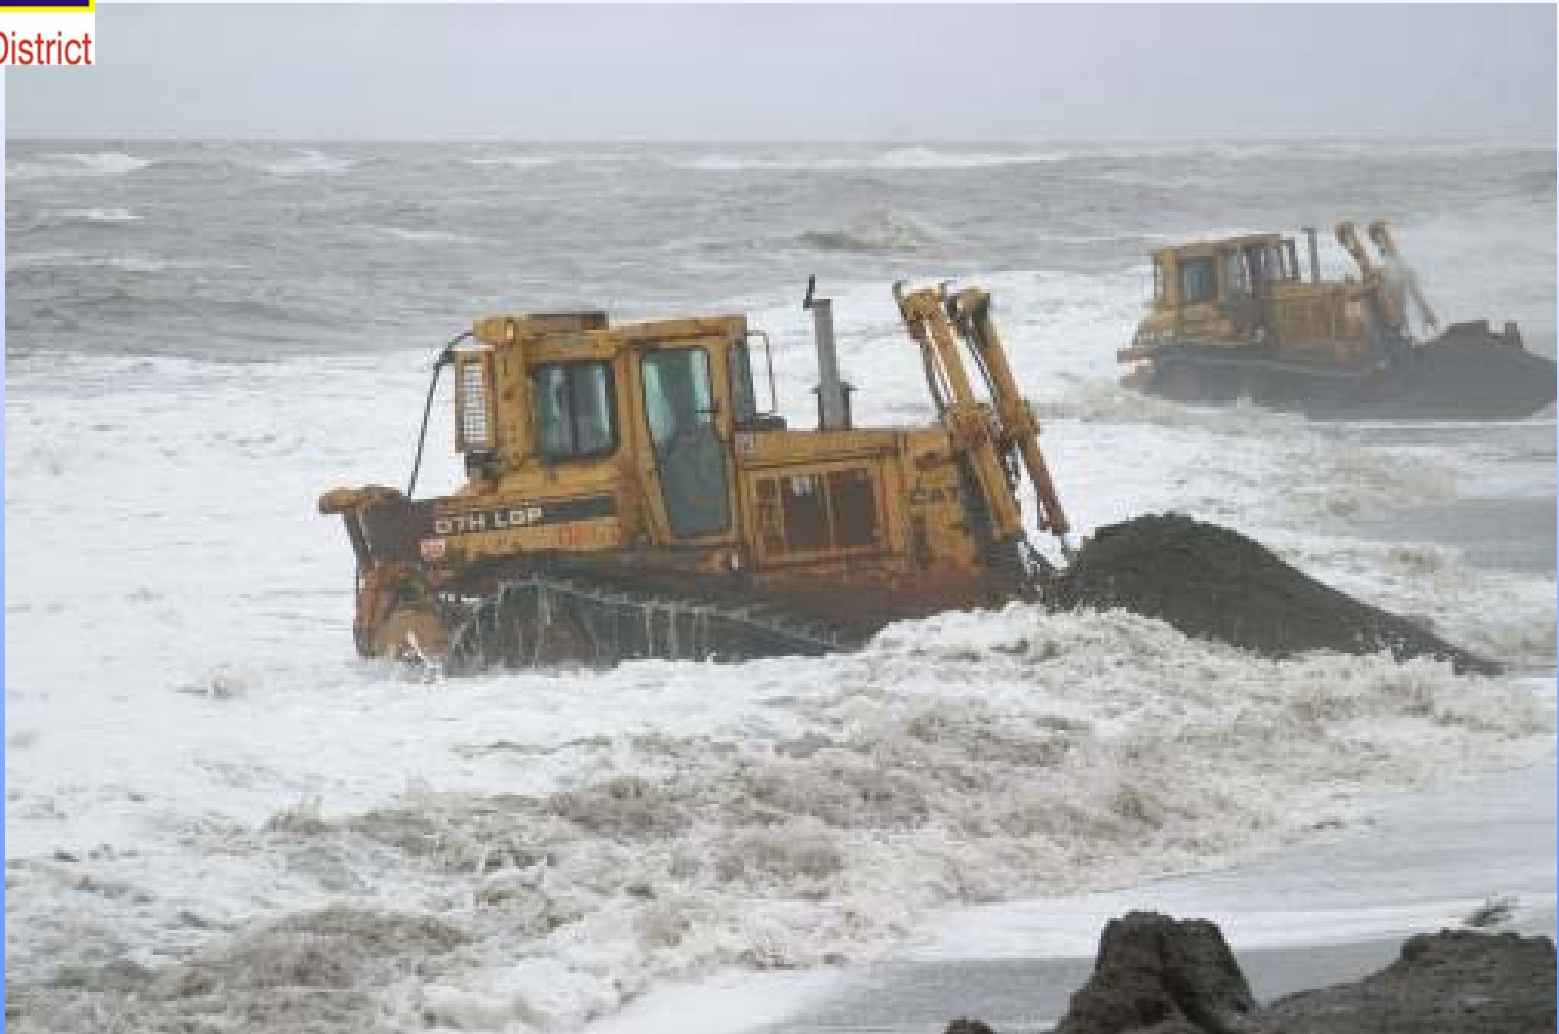
During storm events heavy equipment is mobilized to push beach material up onto the beach (2002 storm).

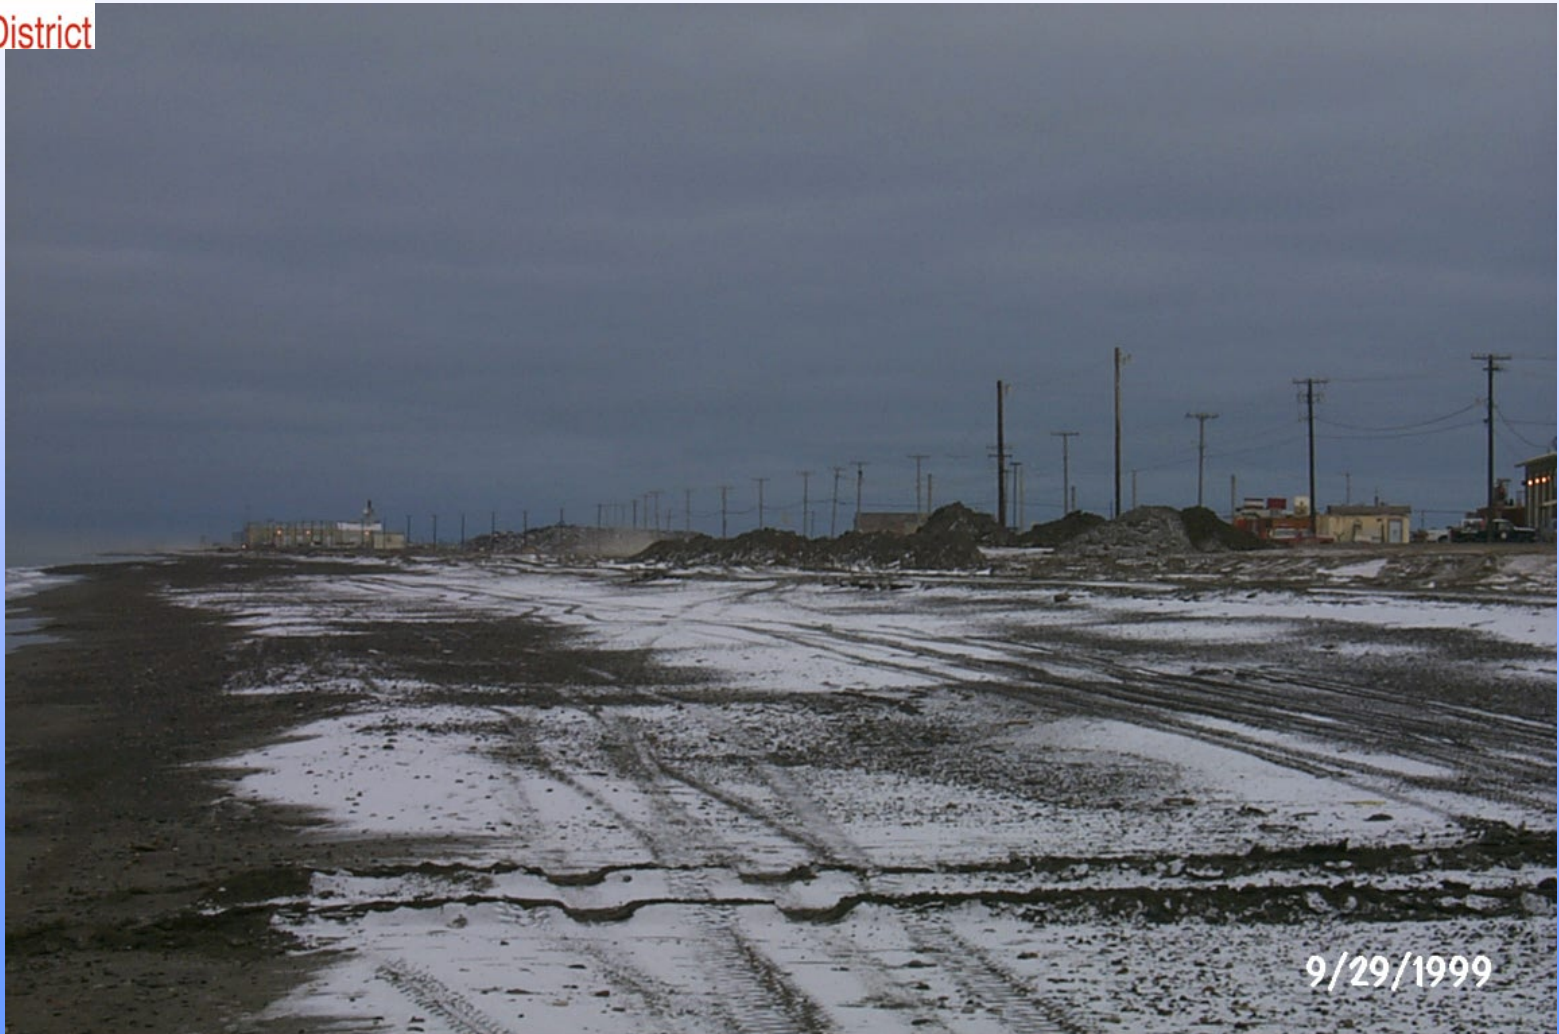
Material pile are placed along the road side constantly to provide sacrificial material during storm events
